Man

VIN: WMA10SZZXBW158396

Generated on 05/12/2025, 02:12 PM

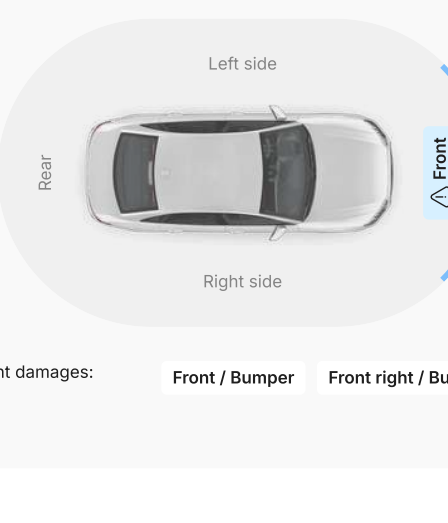
11/2016

Front damages:

Front / Bumper

Front right / Bumper

Front

€1,501 – €3,000

DMVR/Material damage true value

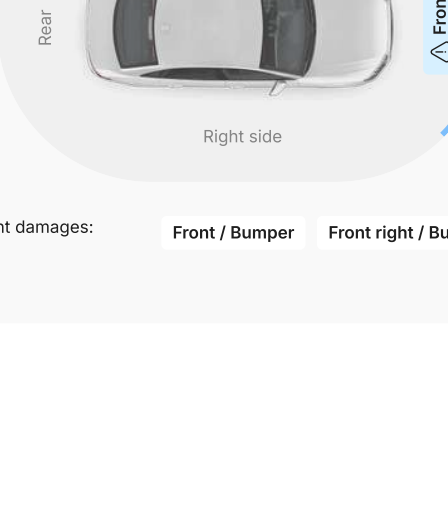
09/2017

Front damages:

Front / Bumper

Front right / Bumper

Front

€1,501 – €3,000

DMVR/Material damage true value

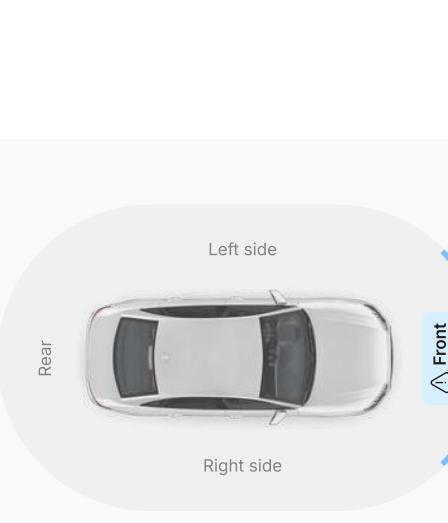
12/2018

Front damages:

Front / Bumper

Front left / Bumper

Front

€1,501 – €3,000

DMVR/Material damage true value
