Man

VIN: WMA10SZZXBW158396

Generated on 05/12/2025, 02:12 PM

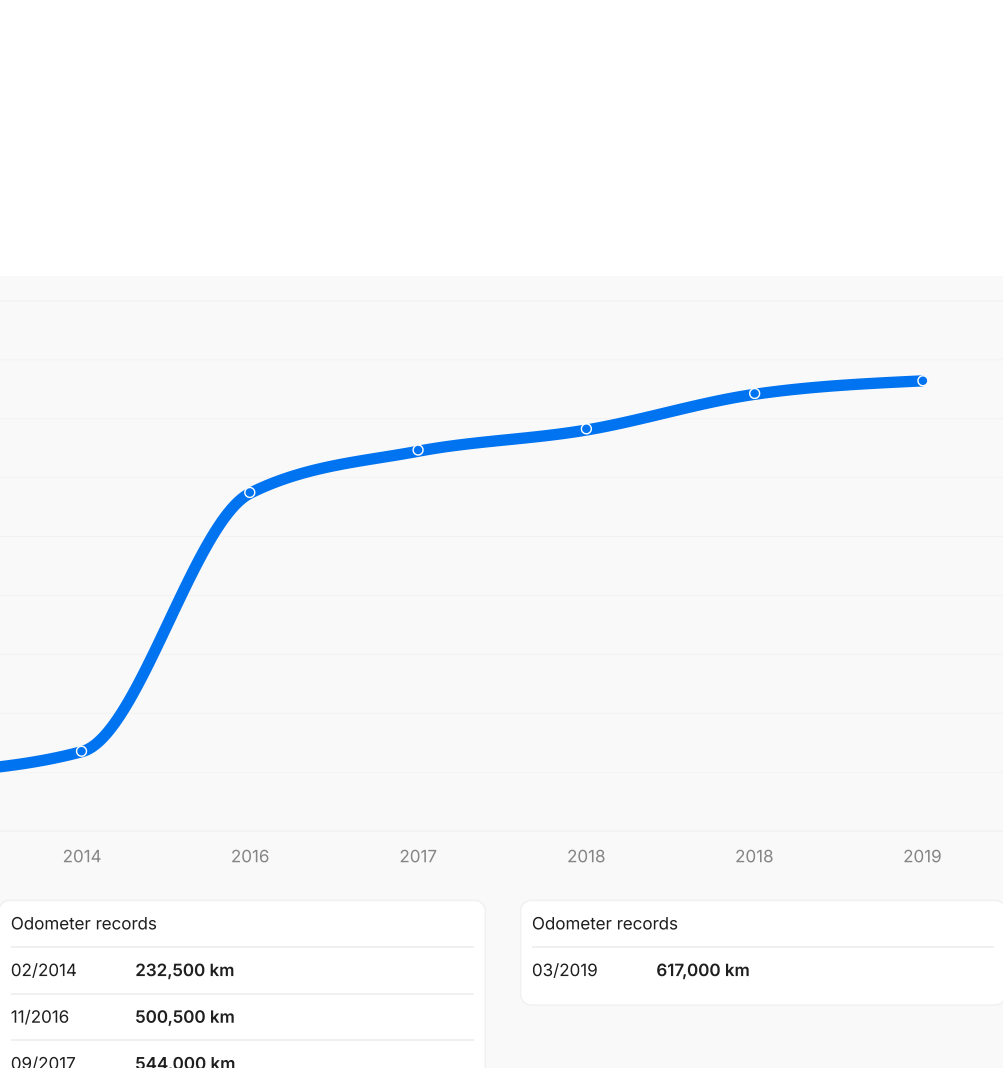
- Last known mileage: 617,000 km
- 6 mileage records found

Odometer records	
02/2014	232,500 km
11/2016	500,500 km
09/2017	544,000 km
02/2018	566,000 km
12/2018	603,000 km

Odometer records	
03/2019	617,000 km
